**Flood Control Project Maintenance
Levee Inspections****LMA District Cover Sheet****Spring 2014 Levee Inspection Results****Reclamation District No. 0563 Tyler Island**

Spring 2014 Levee Inspection Results

Reclamation District No. 0563 Tyler Island

Waterway			Bank	Unit Miles
Unit No. 01 Georgiana Slough (Tyler Island)			Left	12.38
	Spring (March - May)	Summer (June - August)	(September - November) Fall	Winter (December - February)
Unit Maintenance Rating (Fall Only)				
Date of Inspection	03/25/2014 - 03/26/2014			
DWR Inspector	Richard Willoughby			
Accompanied By	Steve Mello RD 563

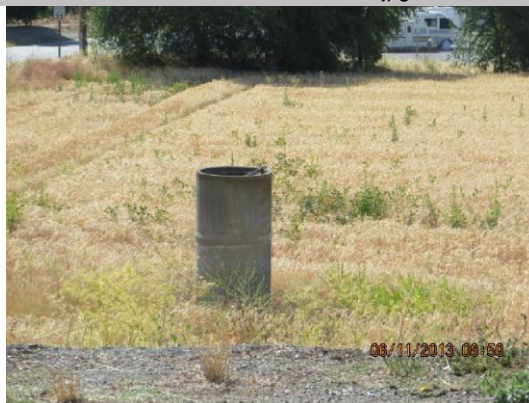
Photo 1 of 1 : UCIP_1130.jpg

LM Start	0.04	Rating **	M	Issue No.	81
LM End	0.04	Issue Type +	En	Location *	WS
Category	Supplemental			GPS Latitude/Longitude	
				Start	End
Item	DWR UCIP Field Study			38.234936 °	38.234936 °
				-121.517528 °	-121.517528 °
DWR ID	DWR_RD0563_01_s _ 2014_81				
Action/Comments					
Inspector Comments: FS_ID:14864					
EP_NO: N/A					
Repair Type:					
Crossing Status:					
UCIP Comments: Need to determine disposition of pipe. Was it abandoned properly?					
FIELD_STRUCT_DESC: 10-inch pipe through levee unknown feet below crown. 36-inch concrete stand pipe at landward toe. Originally included in the 1954 O&M manual. (Unable to located pipe 6/11/2013). FS Date: 6/11/2013

36-inch concrete standpipe on LS toe.

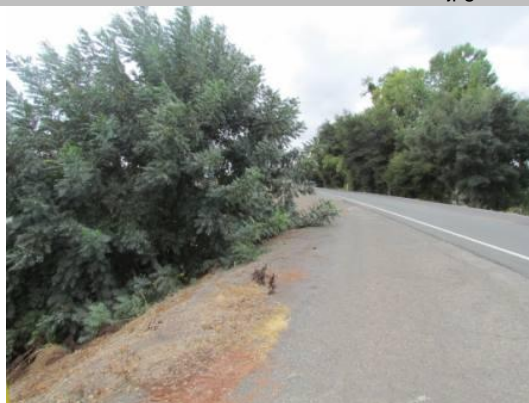
Photo 1 of 1 : richard_s_20140318_804.jpg

Looking southwest at overgrown trees on landside slope.

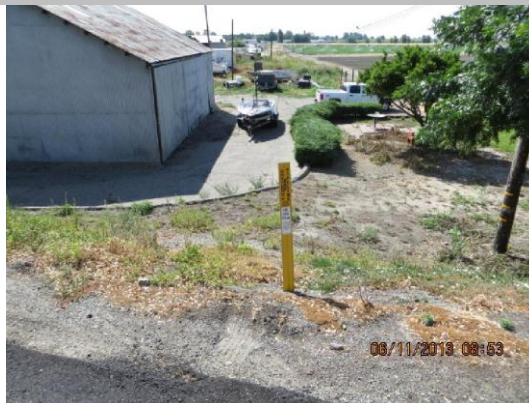
Photo 1 of 1 : UCIP_1132.jpg

LM Start	0.22	Rating **	M	Issue No.	108
LM End	0.22	Issue Type +	En	Location *	LS
Category	Supplemental			GPS Latitude/Longitude	
				Start	End
Item	DWR UCIP Field Study			38.233027 °	38.233027 °
				-121.519631 °	-121.519631 °
DWR ID	DWR_RD0563_01_s _ 2014_108				
Action/Comments					
Inspector Comments: FS_ID:14865 EP_NO: 3448 Repair Type: Crossing Status: UCIP Comments: Sign on waterside slope should be cleared of vegetation. FIELD_STRUCT_DESC: 4.5-inch gas line through levee 4.0 feet below crown and across channel (Permit No. 3448, 1961). Large warning sign on WS slope. FS Date: 6/11/2013

Gasline marker on LS shoulder.

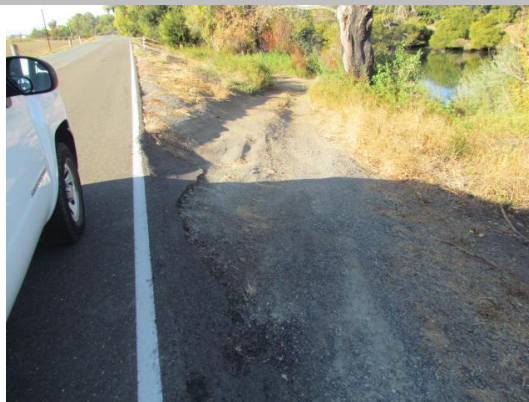
Photo 1 of 1 : richard_s_20140318_801.jpg

LM Start	0.41	Rating **	M	Issue No.	16
LM End	0.41	Issue Type +	Ma	Location *	WS
Category	Earthen Levee			GPS Latitude/Longitude	
				Start	End
Item	Slope Stability			38.230841 °	38.230841 °
				-121.521898 °	-121.521898 °
DWR ID	DWR_RD0563_01_f_2013_16				
Action/Comments					
Repair the levee slope damaged by vehicle traffic and prevent access where possible.					
Inspector Comments: Slope damage is due to fishermen vehicle traffic.

Looking southwest at slope damage caused by vehicle traffic.

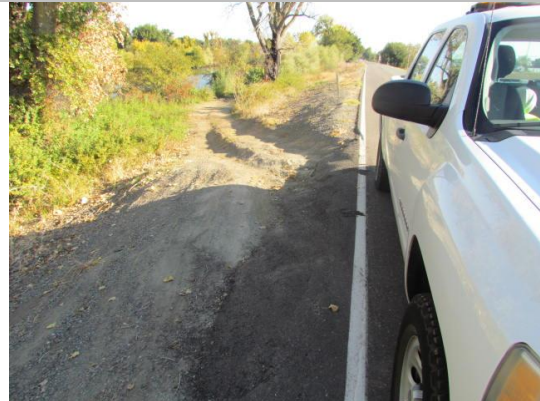
Photo 1 of 1 : richard_s_20140318_809.jpg

LM Start	0.45	Rating **	M	Issue No.	26
LM End	0.45	Issue Type +	Ma	Location *	WS
Category	Earthen Levee			GPS Latitude/Longitude	
				Start	End
Item	Slope Stability			38.230460 °	38.230460 °
				-121.522324 °	-121.522324 °
DWR ID	DWR_RD0563_01_f_2013_26				
Action/Comments					
Repair the levee slope damaged by vehicle traffic and prevent access where possible.					
Inspector Comments: Slope damage due to fishermen vehicle traffic.

Looking northwest at slope damage caused by vehicle traffic.

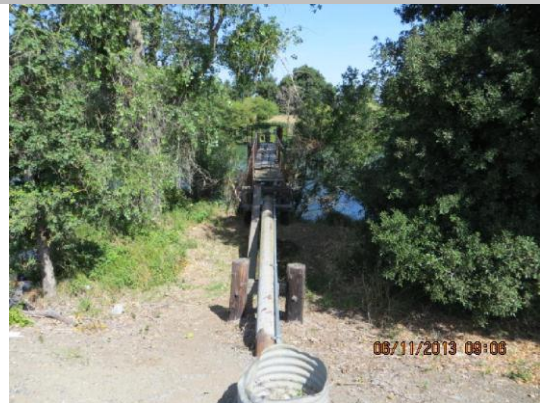
Photo 1 of 1 : UCIP_1136.jpg

LM Start	0.48	Rating **	M	Issue No.	109
LM End	0.48	Issue Type +	En	Location *	WS
Category	Supplemental			GPS Latitude/Longitude	
				Start	End
Item	DWR UCIP Field Study			38.230185 °	38.230185 °
				-121.522631 °	-121.522631 °
DWR ID	DWR_RD0563_01_s_2014_109				
Action/Comments					
Inspector Comments: FS_ID:14866					
EP_NO: 11218					
Repair Type:					
Crossing Status:					
UCIP Comments: Pipe leaking at various points on WS berm. Failure on berm may indicate potential for failure within the levee. Good candidate for video inspection.					
FIELD_STRUCT_DESC: 12-inch steel pipe through the levee 5.0 feet below the crown. Walkway to pump on pile structure in stream. Siphon breaker in a 24-inch CMP riser on the waterward shoulder. 1" air and vacuum valve and a 15' tall by 36" diameter concrete standpipe at the LS toe (ABO No. 11218, 1975). Originally included in the 1954 O&M manual.					
FS Date: 6/11/2013

Pipe and pier on WS.

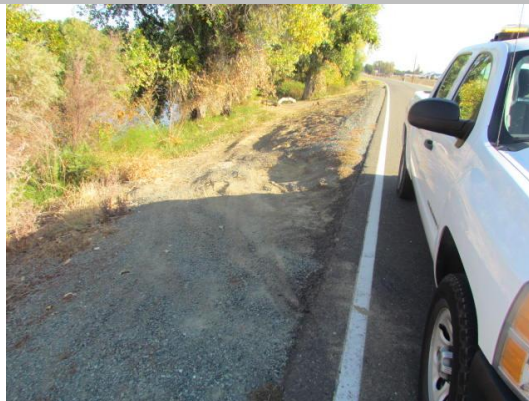
Photo 1 of 1 : richard_s_20140318_816.jpg

LM Start	0.59	Rating **	M	Issue No.	34
LM End	0.59	Issue Type +	Ma	Location *	WS
Category	Earthen Levee			GPS Latitude/Longitude	
				Start	End
Item	Slope Stability			38.228948 °	38.228948 °
				-121.523904 °	-121.523904 °
DWR ID	DWR_RD0563_01_f_2013_34				
Action/Comments					
Repair the levee slope damaged by vehicle traffic and prevent access where possible.					
Inspector Comments: Slope damage is due to fishermen vehicle traffic.

Looking northwest at slope damage caused by vehicle traffic.

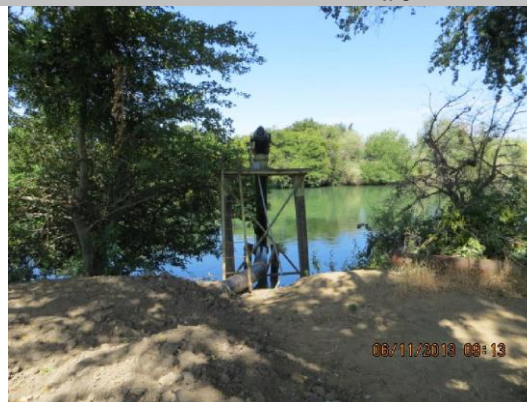
Photo 1 of 1 : UCIP_1139.jpg

LM Start	0.75	Rating **	M	Issue No.	110
LM End	0.75	Issue Type +	En	Location *	WS
Category	Supplemental			GPS Latitude/Longitude	
				Start	End
Item	DWR UCIP Field Study			38.227262 °	38.227262 °
				-121.525844 °	-121.525844 °
DWR ID	DWR_RD0563_01_s _ 2014_110				
Action/Comments					
Inspector Comments: FS_ID:14867					
EP_NO: 11203					
Repair Type:					
Crossing Status:					
UCIP Comments: Signs of leak in pipe at levee slope on both LS and WS where pipe enters levee. Moist soil at LS toe indicates possible internal leak. Evidence of recent pipe repair on WS. Pipe debris on WS toe should be removed.					
FIELD_STRUCT_DESC: 12-inch steel irrigation pipe through the levee 5.0 feet below the crown. Slant pump on bank. Siphon breaker and switch box on waterward slope. Service pole on landward slope. (ABO No. 11203, 1971)					
FS Date: 6/11/2013

Slant pump on WS berm.

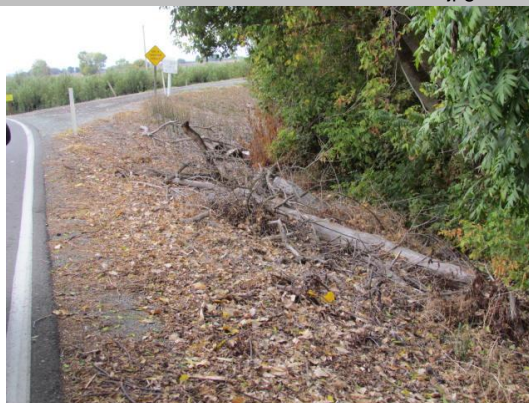
Photo 1 of 2 : richard_s_20140318_792.jpg

LM Start	0.86	Rating **	M	Issue No.	9
LM End	0.86	Issue Type +	Ma	Location *	WS
Category	Earthen Levee			GPS Latitude/Longitude	
				Start	End
Item	Encroachments			38.225685 °	38.225685 °
				-121.526288 °	-121.526288 °
DWR ID	DWR_RD0563_01_s _ 2012_9				
Action/Comments					
Prunings					
Inspector Comments: Prunings on waterside slope should be burned or removed.

Looking southwest at tree limbs on waterside slope.

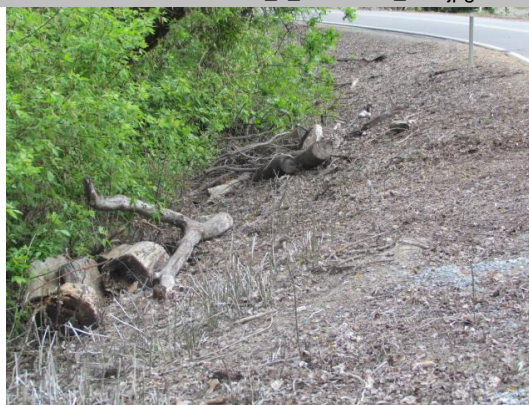
Photo 2 of 2 : richard_s_20140328_464.jpg

Looking northeast at tree limbs on waterward slope.

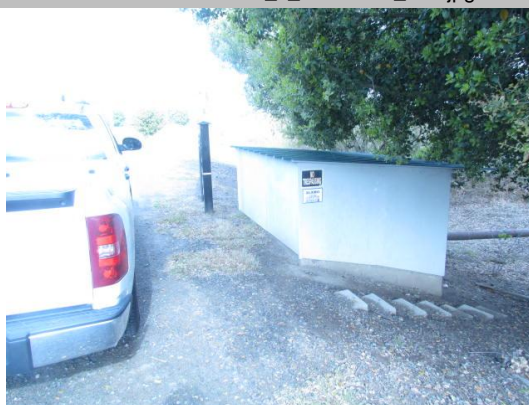
Photo 1 of 1 : richard_s_20140318_799.jpg

LM Start	0.95	Rating **	M	Issue No.	13
LM End	0.95	Issue Type +	En	Location *	CR
Category	Earthen Levee			GPS Latitude/Longitude	
				Start	End
Item	Encroachments			38.225575 °	38.225575 °
				-121.527815 °	-121.527815 °
DWR ID	DWR_RD0563_01_s _ 2012_13				
Action/Comments					
Fence

Looking south at pump shed on waterside slope and gate across levee crown.

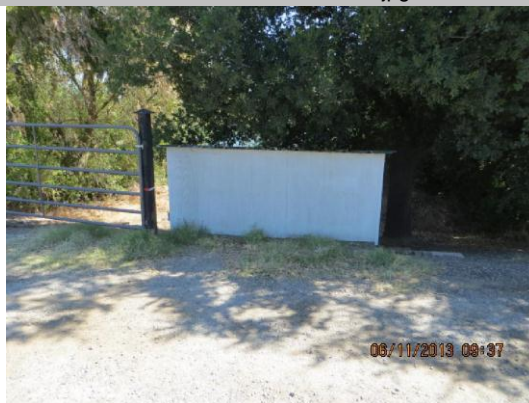
Photo 1 of 1 : UCIP_1143.jpg

LM Start	0.95	Rating **	M	Issue No.	111
LM End	0.95	Issue Type +	En	Location *	CR
Category	Supplemental			GPS Latitude/Longitude	
				Start	End
Item	DWR UCIP Field Study			38.225594 °	38.225594 °
				-121.527812 °	-121.527812 °
DWR ID	DWR_RD0563_01_s_2014_111				
Action/Comments					
Inspector Comments: FS_ID:14870					
EP_NO: 11210					
Repair Type:					
Crossing Status:					
UCIP Comments: Pipe does not have sufficient cover at crown.					
FIELD_STRUCT_DESC: 1 of 2: 6-inch pipe through the levee 3-inches below the crown. Pump and gate valve in pump house on waterward slope. Service pole on landward slope. (ABO No. 11210, 1971). 1-inch PVC electrical conduit through levee at same location. Originally included in 1954 O&M manual.					
FS Date: 6/11/2013

Pumphouse on WS shoulder.

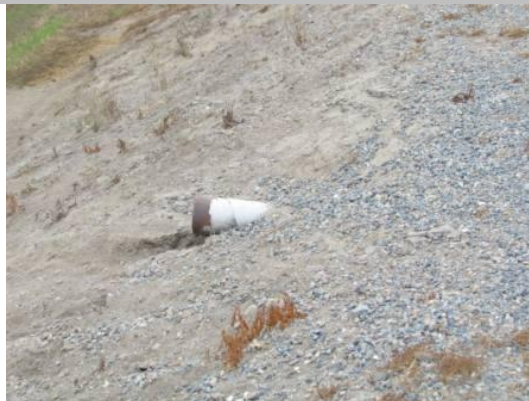
Photo 2 of 2 : richard_s_20140318_942.jpg

LM Start	0.98	Rating **	M	Issue No.	937
LM End	0.98	Issue Type +	Ma	Location *	CR
Category	Earthen Levee			GPS Latitude/Longitude	
				Start	End
Item	Encroachments			38.225813 °	38.225813 °
				-121.528198 °	-121.528198 °
DWR ID	DWR_RD0563_01_s_2012_937				
Action/Comments					
Pipe					
Inspector Comments: Abandoned pipe should be removed.

Looking southwest at abandoned pipe on landside slope.

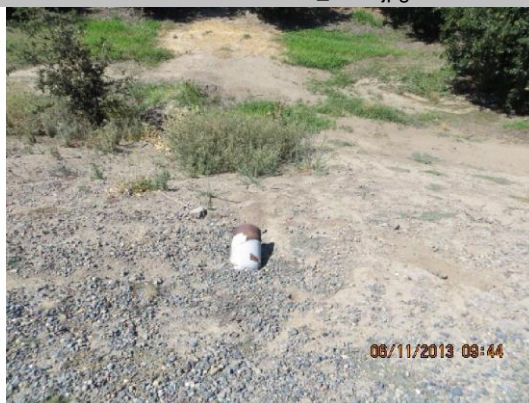
Photo 1 of 1 : UCIP_1149.jpg

LM Start	0.98	Rating **	M	Issue No.	112
LM End	0.98	Issue Type +	En	Location *	CR
Category	Supplemental			GPS Latitude/Longitude	
				Start	End
Item	DWR UCIP Field Study			38.225829 °	38.225829 °
				-121.528200 °	-121.528200 °
DWR ID	DWR_RD0563_01_s _ 2014_112				
Action/Comments					
Inspector Comments: FS_ID:14872					
EP_NO: 11210					
Repair Type:					
Crossing Status:					
UCIP Comments: Flap gate rusted in closed position.					
FIELD_STRUCT_DESC: 2 of 2: 8-inch pipe through the levee 3.0 feet below the crown. Flap gate on waterward end. Landward end open (ABO No. 11210, 1971).					
FS Date: 6/11/2013

Pipe open on LS slope.

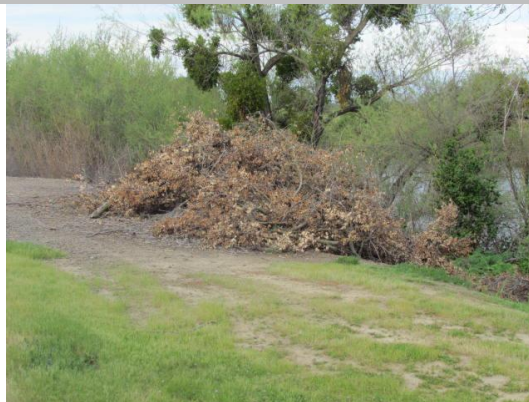
Photo 1 of 1 : richard_s_20140328_465.jpg

LM Start	1.21	Rating **	M	Issue No.	69
LM End	1.21	Issue Type +	En	Location *	WS
Category	Earthen Levee			GPS Latitude/Longitude	
				Start	End
Item	Encroachments			38.226748 °	38.226748 °
				-121.531756 °	-121.531756 °
DWR ID	DWR_RD0563_01_f _ 2013_69				
Action/Comments					
Prunings					
Inspector Comments: Pruning pile should be burned or removed from waterward slope.

Looking west at pruning pile on waterward slope.

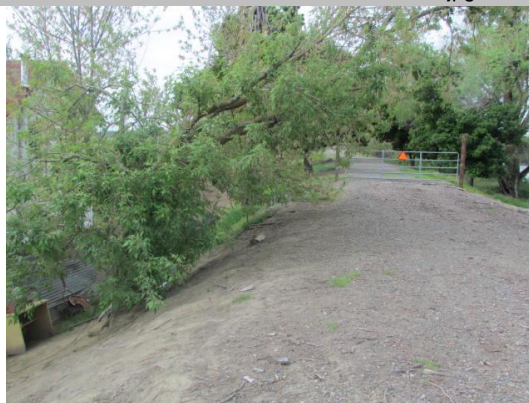
Photo 1 of 1 : richard_s_20140328_466.jpg

Looking south at untrimmed trees on landward slope.

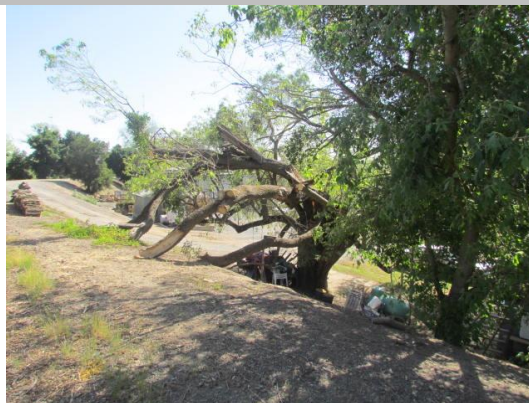
Photo 1 of 1 : richard_s_20140318_938.jpg

LM Start	1.25	Rating **	A/W	Issue No.	103
LM End	1.25	Issue Type +	Ma	Location *	LS
Category	Earthen Levee			GPS Latitude/Longitude	
				Start	End
Item	Encroachments				o
					o
DWR ID	DWR_RD0563_01_s _ 2013_103				
Action/Comments					
Tree or limb					
Inspector Comments: Broken tree branches on landward slope.

Looking northeast at broken tree branch on landward slope.

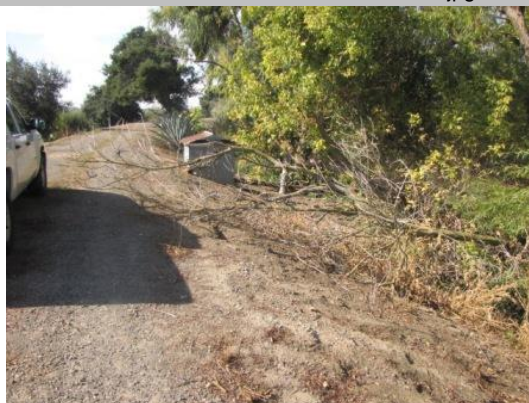
Photo 1 of 1 : richard_s_20140318_805.jpg

LM Start	1.42	Rating **	A/W	Issue No.	19
LM End	1.42	Issue Type +	Ma	Location *	WS
Category	Earthen Levee			GPS Latitude/Longitude	
				Start	End
Item	Encroachments			38.224367 °	38.224367 °
				-121.534165 °	-121.534165 °
DWR ID	DWR_RD0563_01_s _ 2012_19				
Action/Comments					
Tree or limb					
Inspector Comments: Broken tree along waterside slope.

Looking south at a downed tree on waterside slope.

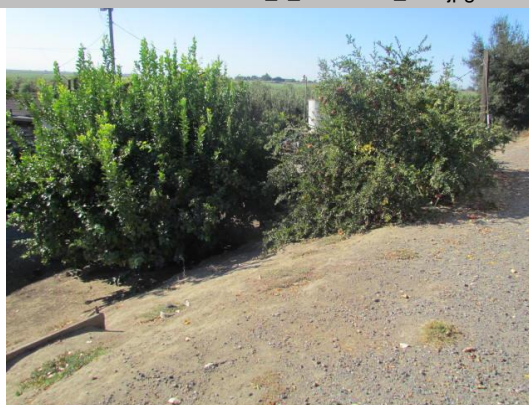
Photo 2 of 2 : richard_s_20140318_924.jpg

LM Start	1.43	Rating **	M	Issue No.	86
LM End	1.43	Issue Type +	En	Location *	LS
Category	Earthen Levee			GPS Latitude/Longitude	
				Start	End
Item	Vegetation			38.224351 °	38.224351 °
				-121.534209 °	-121.534209 °
DWR ID	DWR_RD0563_01_f _ 2013_86				
Action/Comments					
Landscaping

Looking southeast at dense landscaping on the landward slope.

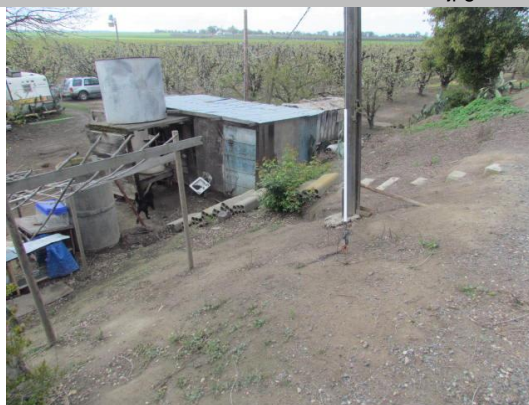
Photo 2 of 3 : richard_s_20140318_790.jpg

Looking southeast at a tool shed at the landside toe.

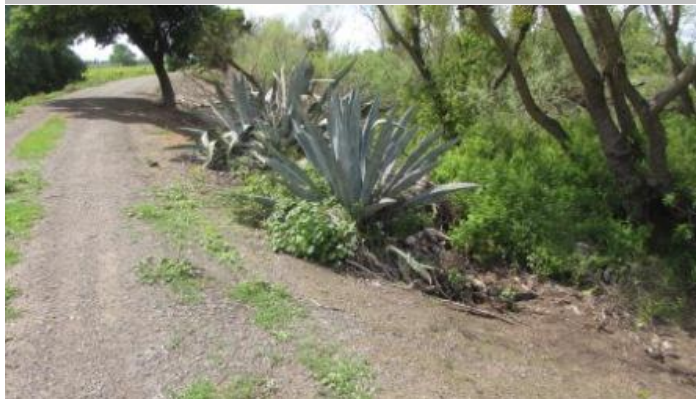
Photo 2 of 2 : richard_s_20140318_788.jpg

Updated view looking upstream at a century plant on waterside shoulder slope.

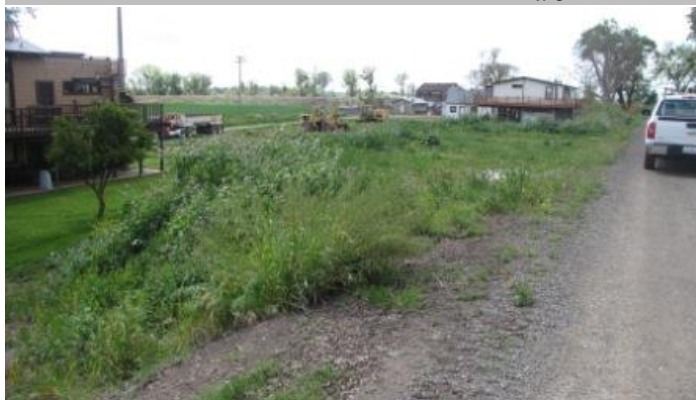
Photo 3 of 12 : richard_s_20140318_882.jpg

Looking southeast at earthen pad on landside shoulder covering retaining wall.

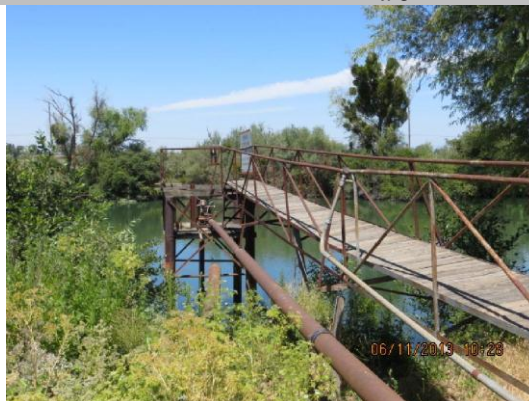
Photo 1 of 1 : UCIP_1154.jpg

Pump on pile structure with walkway structurally failing. WS berm.

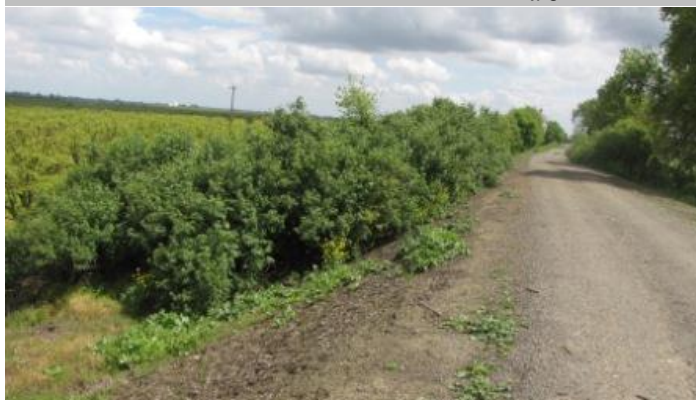
Photo 1 of 2 : richard_s_20140318_796.jpg

Looking southeast at elderberry on the landside slope and toe.

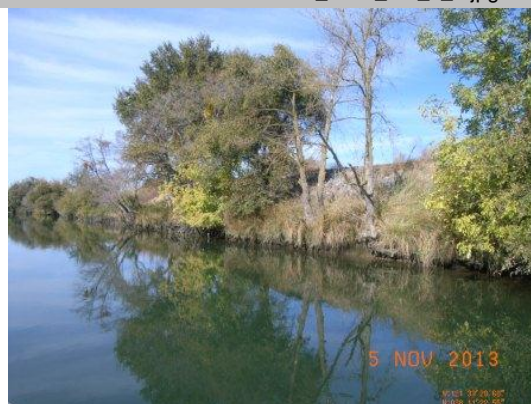
Photo 1 of 1 : USACE2013A_GEO_9-3_L_6.jpg

LM Start	2.67	Rating **	M	Issue No.	53
LM End	2.87	Issue Type +	Ma	Location *	WS
Category	Supplemental			GPS Latitude/Longitude	
				Start	End
Item	USACE Erosion Survey			38.214133 °	38.211737 °
				-121.537778 °	-121.535436 °
DWR ID					
Action/Comments					
Inspector Comments: 1997 - Loss of rock at toe; pockets of upper berm erosion; very narrow berm width; toe rock problem; erosion pockets in rock. 2002 - New brush boxes at toe of the worst spots. 2005 - Upstream 200 ft removed because of the wide berm. 2006 - Some rock repair pockets behind the brush boxes at the upstream end. 2010 - Some new erosion. 2013: New rock placed on the levee slope. [2013 Site ID: GEO_9-3_L]

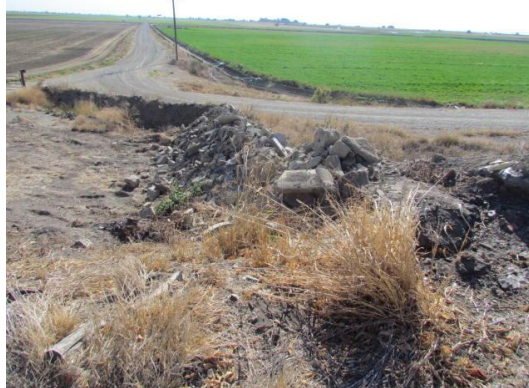
Photo 1 of 2 : richard_s_20140318_939.jpg

LM Start	2.95	Rating **	M	Issue No.	104
LM End	2.95	Issue Type +	Ma	Location *	LS
Category	Earthen Levee			GPS Latitude/Longitude	
				Start	End
Item	Encroachments			38.210966 °	38.210966 °
				-121.534813 °	-121.534813 °
DWR ID	DWR_RD0563_01_f_2013_104				
Action/Comments					
Material					
Inspector Comments: Landowner stockpiled concrete rubble on landward and waterward slope to stop trespassers. Landowner should replace the stockpile with a proper fence.

Looking east at concrete rubble on landward slope.

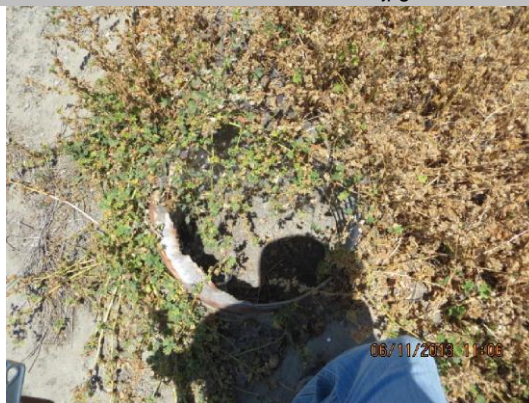
Photo 1 of 1 : UCIP_1159.jpg

LM Start	3.06	Rating **	M	Issue No.	116
LM End	3.06	Issue Type +	En	Location *	LS
Category	Supplemental			GPS Latitude/Longitude	
				Start	End
Item	DWR UCIP Field Study			38.210209 °	38.210209 °
				-121.536313 °	-121.536313 °
DWR ID	DWR_RD0563_01_s_2014_116				
Action/Comments					
Inspector Comments: FS_ID:14885					
EP_NO: N/A					
Repair Type:					
Crossing Status:					
UCIP Comments: Abandoned and should be done so properly. Need to verify disposition of pipe.					
FIELD_STRUCT_DESC: *Abandoned* 6-inch pipe through levee 4.0 feet below crown. Siphon breaker in 24-inch CMP riser on landward shoulder. Open on both ends. Originally included in 1954 O&M manual with the description 1" air valve, brass cock and cover.					
FS Date: 6/11/2013

24-inch CMP standpipe on LS slope.

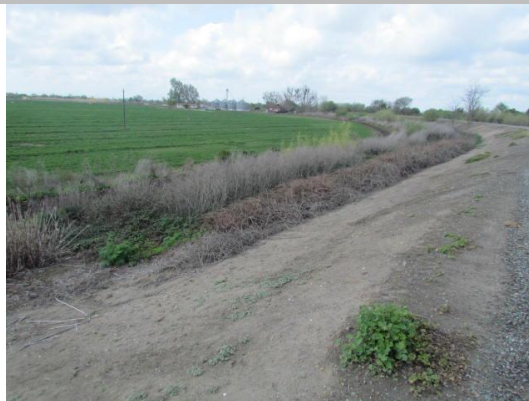
Photo 2 of 2 : richard_s_20140318_905.jpg

Looking southeast at dead berryvine on landside toe.

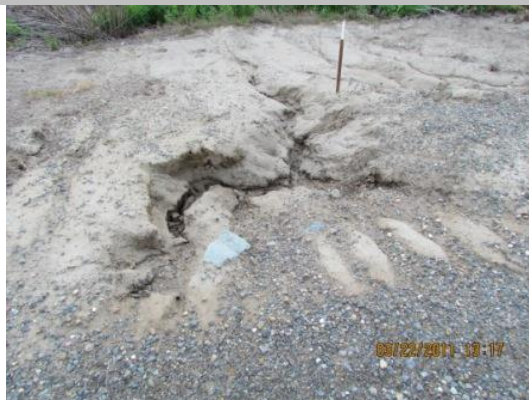
Photo 1 of 4 : richard_s_20140318_910.jpg

LM Start	3.13	Rating **	M	Issue No.	78
LM End	3.13	Issue Type +	Ma	Location *	LS
Category	Earthen Levee			GPS Latitude/Longitude	
				Start	End
Item	Slope Stability			38.210240 °	38.210240 °
				-121.537517 °	-121.537517 °
DWR ID	DWR_RD0563_01_s _ 2012_78				
Action/Comments					
Repair slope instability.

Looking east at slope erosion cause by runoff on landside slope.

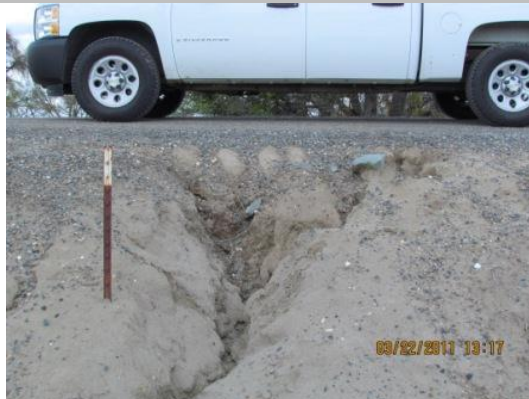
Photo 2 of 4 : richard_s_20140318_911.jpg

Looking west at slope erosion cause by runoff on landside slope.

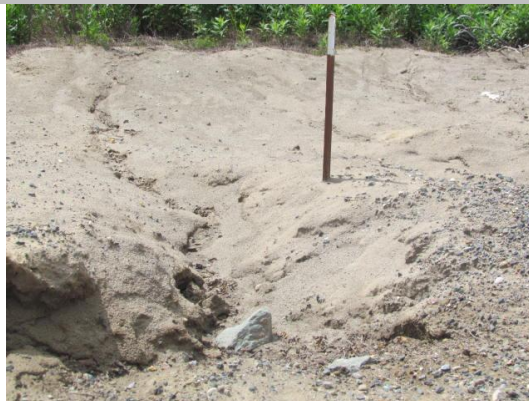
Photo 3 of 4 : richard_s_20140318_912.jpg

LM Start	3.13	Rating **	M	Issue No.	78 (cont)	
LM End	3.13	Issue Type +	Ma	Location *	LS	
Category	Earthen Levee			GPS Latitude/Longitude		
				Start		End
Item	Slope Stability			38.210240 °		38.210240 °
				-121.537517 °		-121.537517 °
DWR ID	DWR_RD0563_01_s _ 2012_78					
Action/Comments						
Repair slope instability.

Looking east at slope erosion. (Updated Spring 2012)

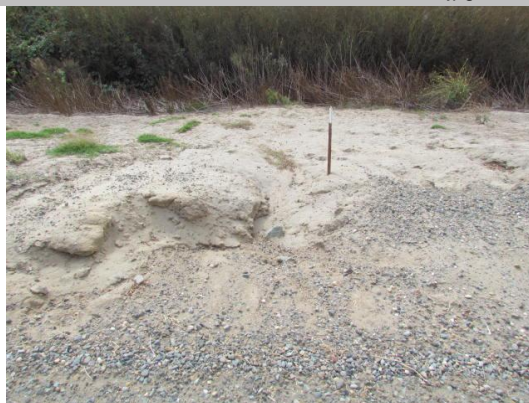
Photo 4 of 4 : richard_s_20140318_913.jpg

Looking east at slope damage on 10/31/2012, no change in status.

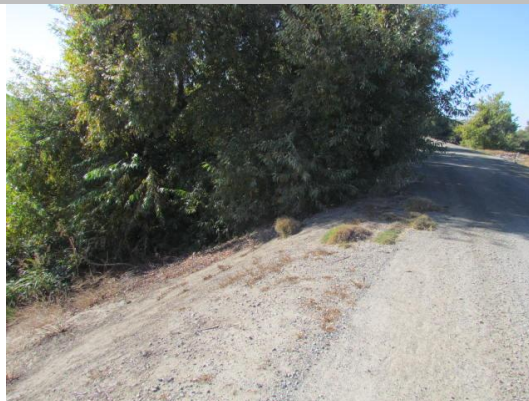
Photo 2 of 2 : richard_s_20140318_898.jpg

Looking south at dense trees on landward slope.

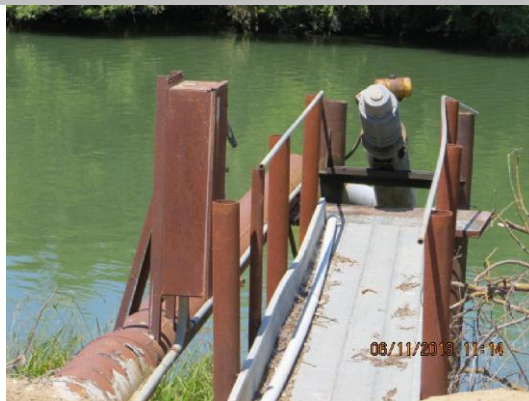
Photo 1 of 1 : UCIP_1160.jpg

LM Start	3.33	Rating **	M	Issue No.	117
LM End	3.33	Issue Type +	En	Location *	LS
Category	Supplemental			GPS Latitude/Longitude	
				Start	End
Item	DWR UCIP Field Study			38.208674 °	38.208674 °
				-121.540280 °	-121.540280 °
DWR ID	DWR_RD0563_01_s _ 2014_117				
Action/Comments					
Inspector Comments: FS_ID:14887					
EP_NO: 12708					
Repair Type:					
Crossing Status:					
UCIP Comments: Pipe heavily corroded. Good candidate for viewo inspection.					
FIELD_STRUCT_DESC: 1 of 2: 14-inch pipe through levee 3.0 feet below crown. Slant pump and gate valve on waterward side. 9'X7' concrete distribution box on LS toe. Service pole on landward shoulder (Permit No. 12708, 1980). Replaced 8-inch pipe under Permit No. 11211 and 1954 O&M manual.					
FS Date: 6/11/2013

Pump and walkway on WS.

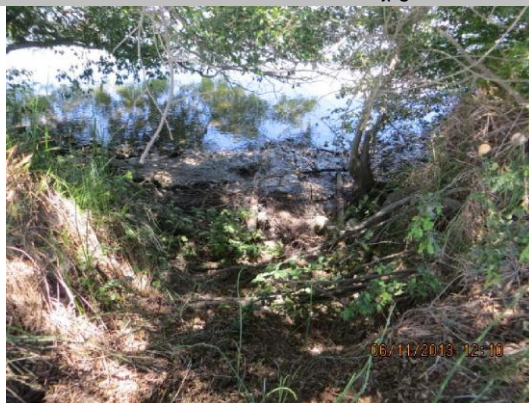
Photo 1 of 1 : UCIP_1434.jpg

Pipe visible on WS toe.

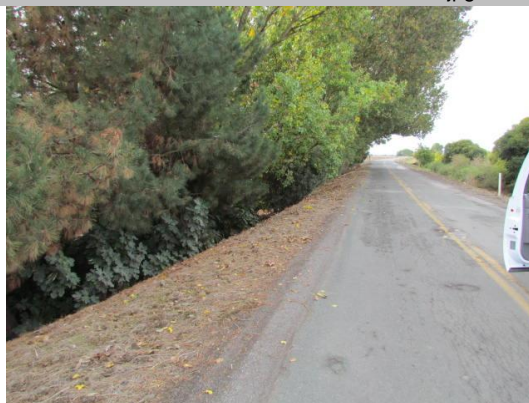
Photo 1 of 1 : richard_s_20140318_925.jpg

Looking south at dense trees on landside slope and toe.

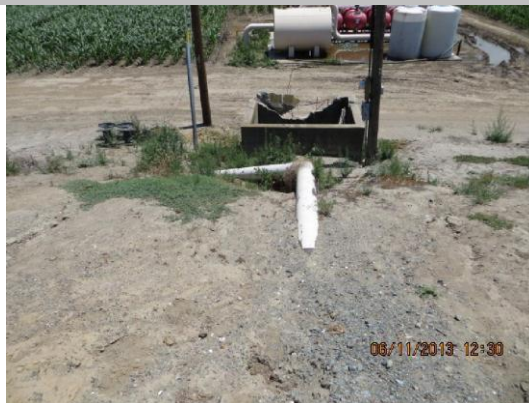
Photo 1 of 1 : UCIP_1164.jpg

Pipe, distribution box, JP, electrical conduit, and booster/filter system on LS.

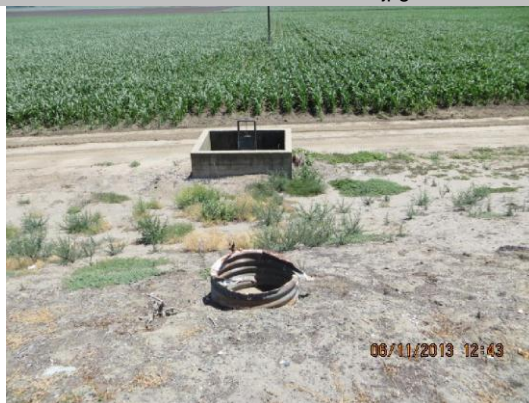
Photo 1 of 1 : UCIP_1169.jpg

Distribution box and 24-inch CMP riser on LS slope.

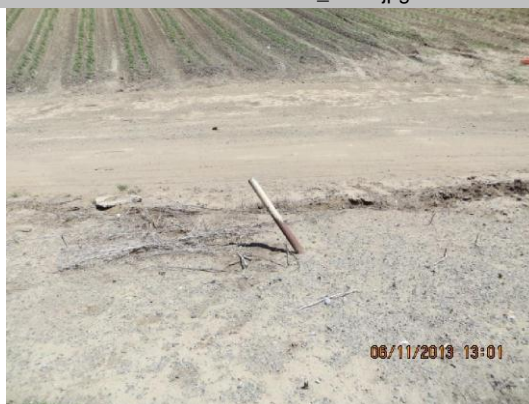
Photo 1 of 1 : UCIP_1444.jpg

Pipe visible on LS slope.

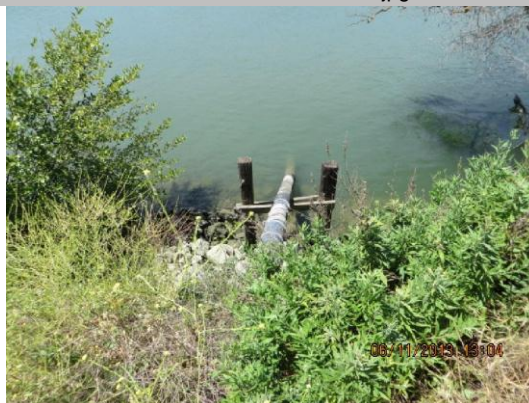
Photo 1 of 1 : UCIP_1171.jpg

Pipe at WS toe.

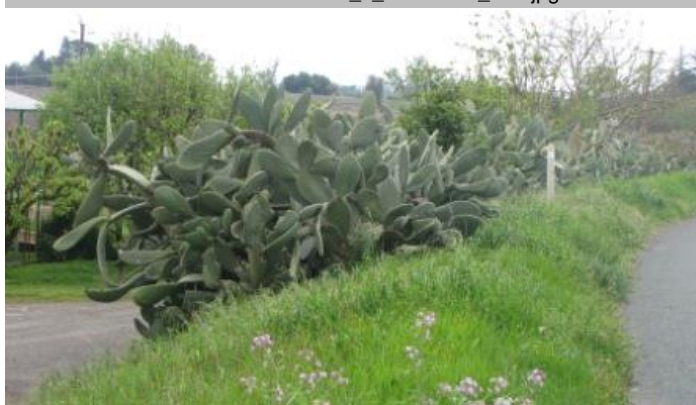
Photo 2 of 2 : richard_s_20140318_807.jpg

Looking at north end of cactus on the landside slope.

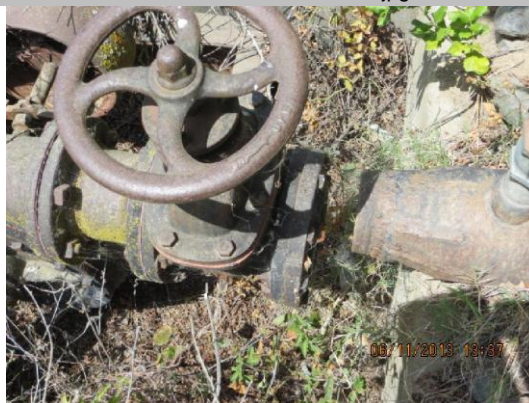
Photo 1 of 1 : UCIP_1182.jpg

No connection to pump on WS shoulder.

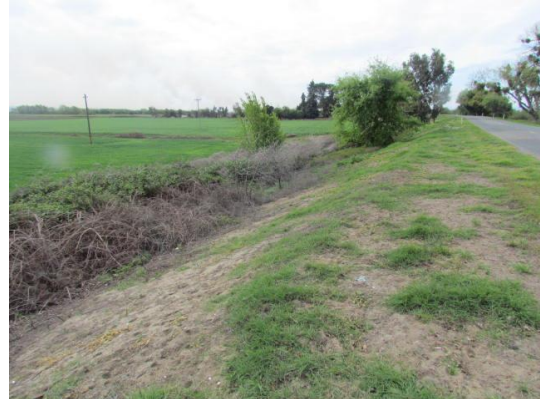
Photo 2 of 2 : richard_s_20140328_477.jpg

Looking south at dense dead berryvines at landward toe.

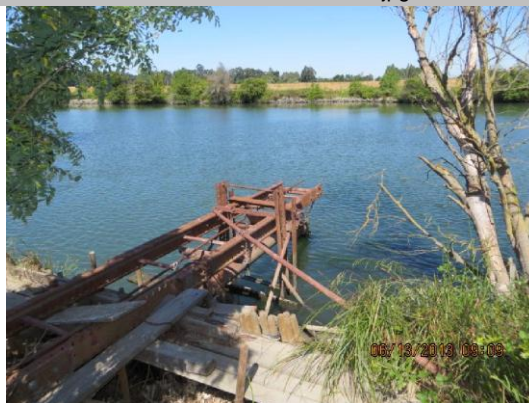
Photo 1 of 1 : UCIP_1188.jpg

Steel walkway support for pipe on WS toe.

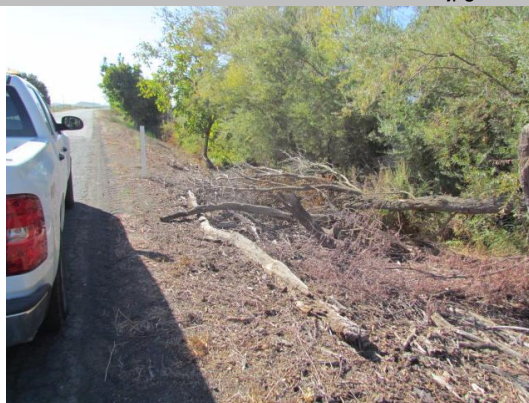
Photo 1 of 1 : richard_s_20140318_916.jpg

Looking south at tree limbs on waterward slope.

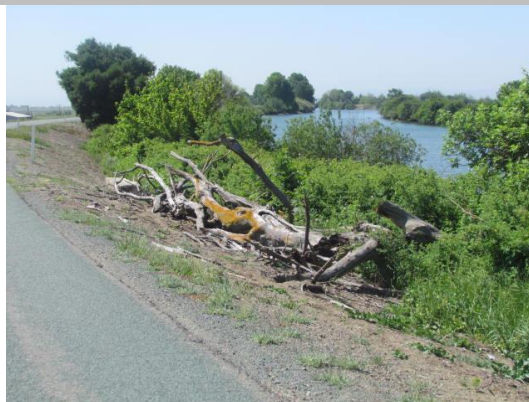
Photo 1 of 1 : richard_s_20140318_935.jpg

Looking southwest at prunings on waterward slope.

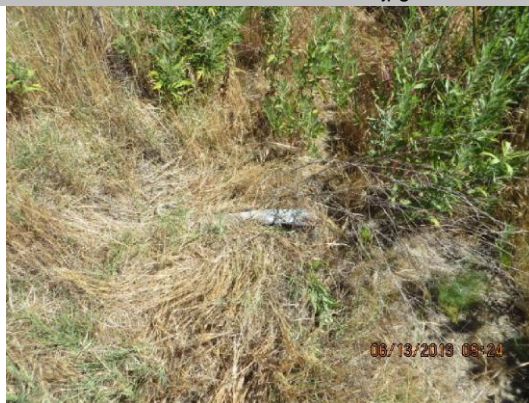
Photo 1 of 1 : UCIP_1191.jpg

Steel parts on LS toe may indicate location of distribution box.

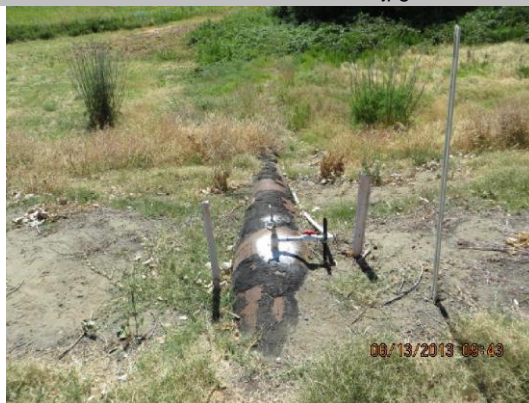
Photo 1 of 1 : UCIP_1192.jpg

Pipe, vent, and filler valve on LS shoulder.

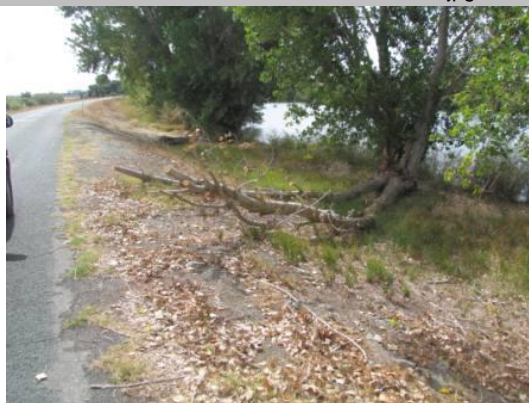
Photo 1 of 1 : richard_s_20140318_926.jpg

Looking southwest at downed limbs on waterside slope.

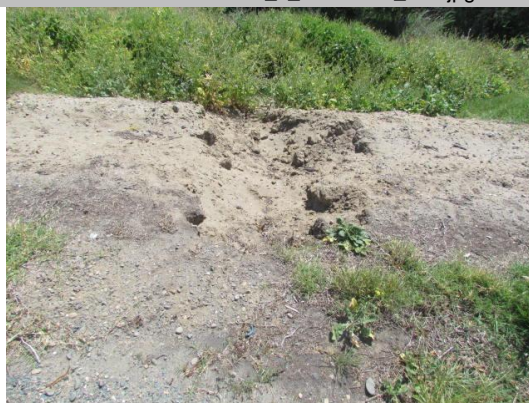
Photo 1 of 1 : richard_s_20140318_937.jpg

Looking east at slope erosion on landward shoulder and slope.

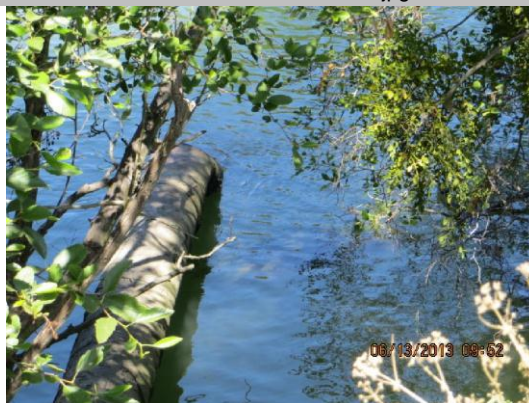
Photo 1 of 1 : UCIP_1448.jpg

Pipe visible on WS toe.

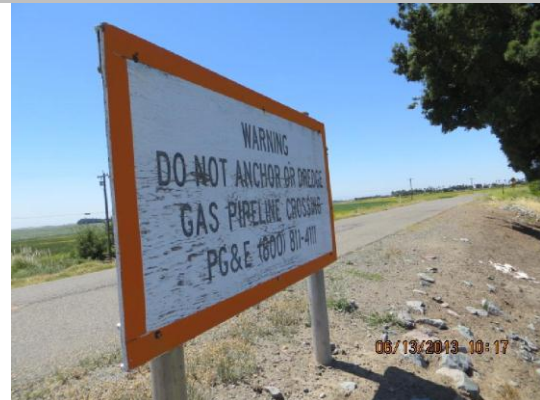
Photo 1 of 1 : UCIP_1439.jpg

Sign on WS shoulder.

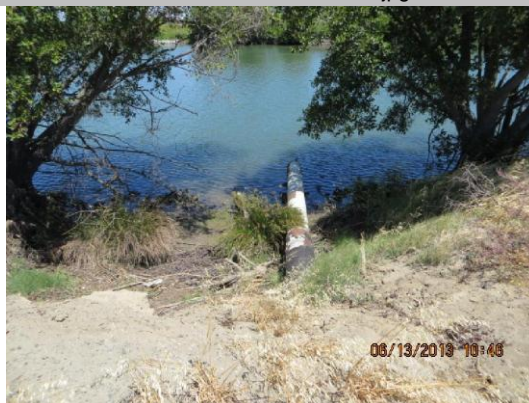
Photo 1 of 1 : UCIP_1194.jpg

Pipe visible on WS toe.

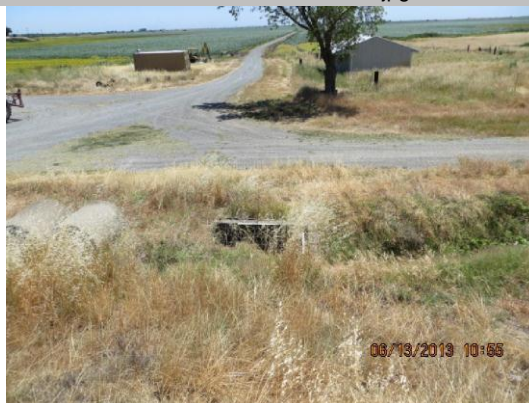
Photo 1 of 1 : UCIP_1197.jpg

DWR ID	DWR_RD0563_01_s_2014_134
Action/Comments	
Inspector Comments: FS_ID:14990	
EP_NO: 11217	
Repair Type:	
Crossing Status:	
UCIP Comments: Pipe appears abandoned and should be done so properly.	
FIELD_STRUCT_DESC: 1 of 11: 12-inch steel irrigation siphon pipe through the levee 3.6 feet below the crown. Vent/filler pipe on the landward shoulder and a slide gate in a 7'X9' concrete distribution box on LS toe (ABO No. 11217, 1971). Originally included in 1954 O&M manual.	
FS Date: 6/13/2013

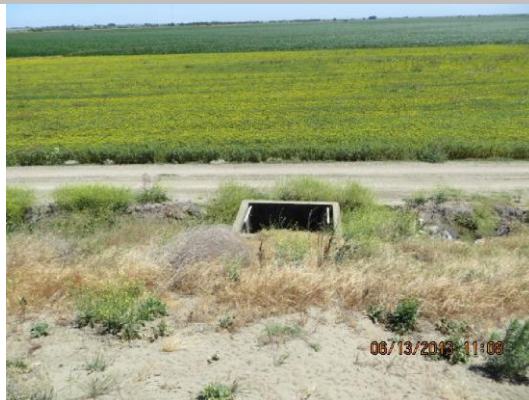
Photo 1 of 1 : UCIP_1446.jpg

DWR ID	DWR_RD0563_01_s_2014_135
Action/Comments	
Inspector Comments: FS_ID:16292	
EP_NO: 11217	
Repair Type:	
Crossing Status:	
UCIP Comments: Appears abandoned and should be done so properly. Slide gate broken.	
FIELD_STRUCT_DESC: 3 of 11: 14-inch pipe through the levee 4.2 feet below the crown. Vent/filler pipe on landward shoulder. Slide gate in 7'X9' concrete distribution box on LS toe (ABO No.11217, 1971). Originally included in the 1954 O&M manual.	
FS Date: 6/13/2013

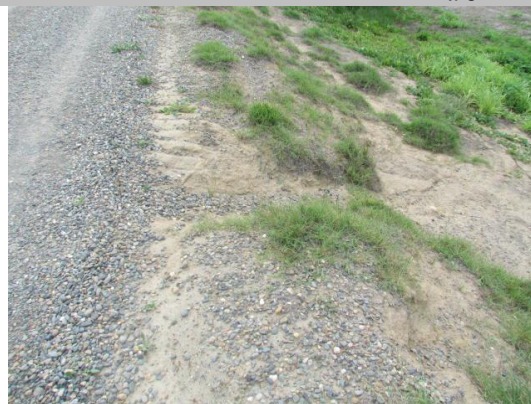
Photo 1 of 2 : richard_s_20140328_479.jpg

Looking north at minor erosion on landward shoulder and slope.

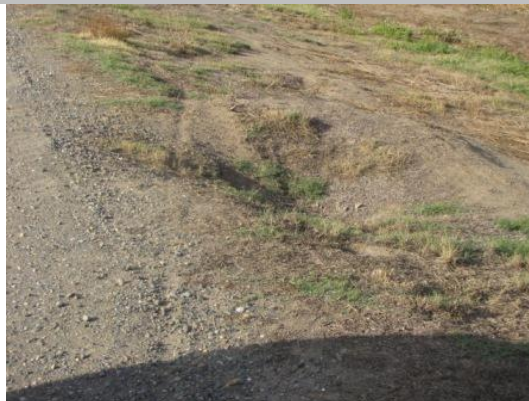
Photo 1 of 4 : richard_s_20140318_906.jpg

Looking northeast a depression on landside shoulder and slope above 10" irrigation pipe four feet below crown.

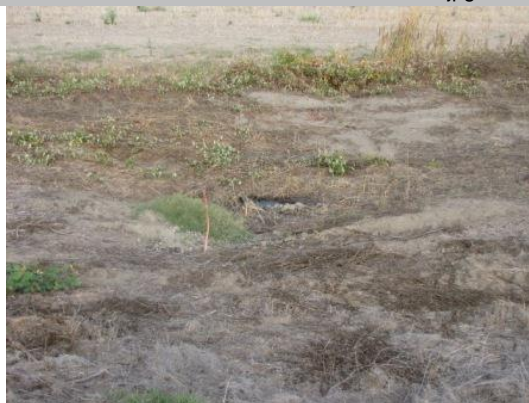
Photo 4 of 4 : richard_s_20140318_909.jpg

Looking east at water ponding at landside toe just above 10" irrigation pipe.

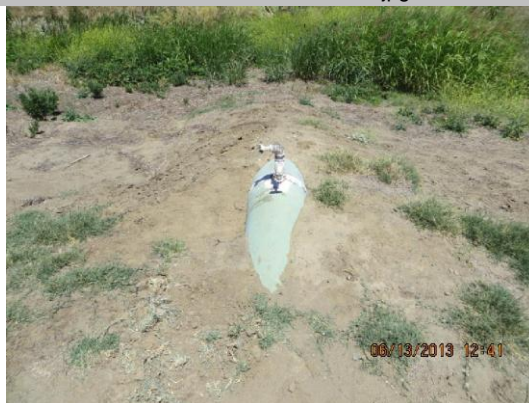
Photo 1 of 1 : UCIP_1203.jpg

Vent/filler on pipe at LS shoulder.

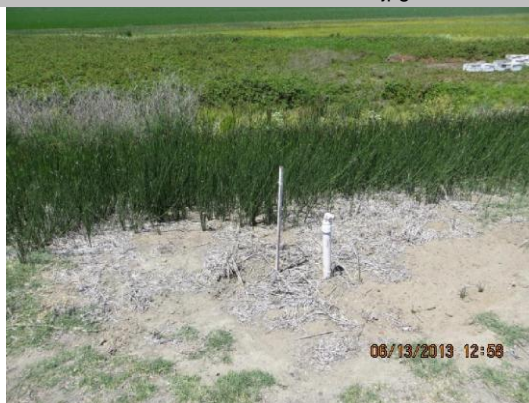
Photo 1 of 1 : UCIP_1206.jpg

Vent and distribution box visible on LS.

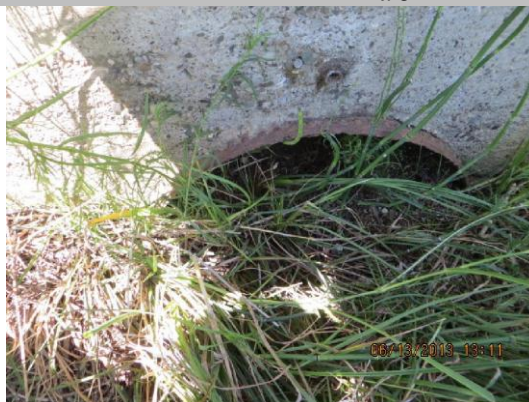
Photo 1 of 1 : UCIP_1207.jpg

Pipe at concrete headwall on WS slope.
